Community Asset is Restored

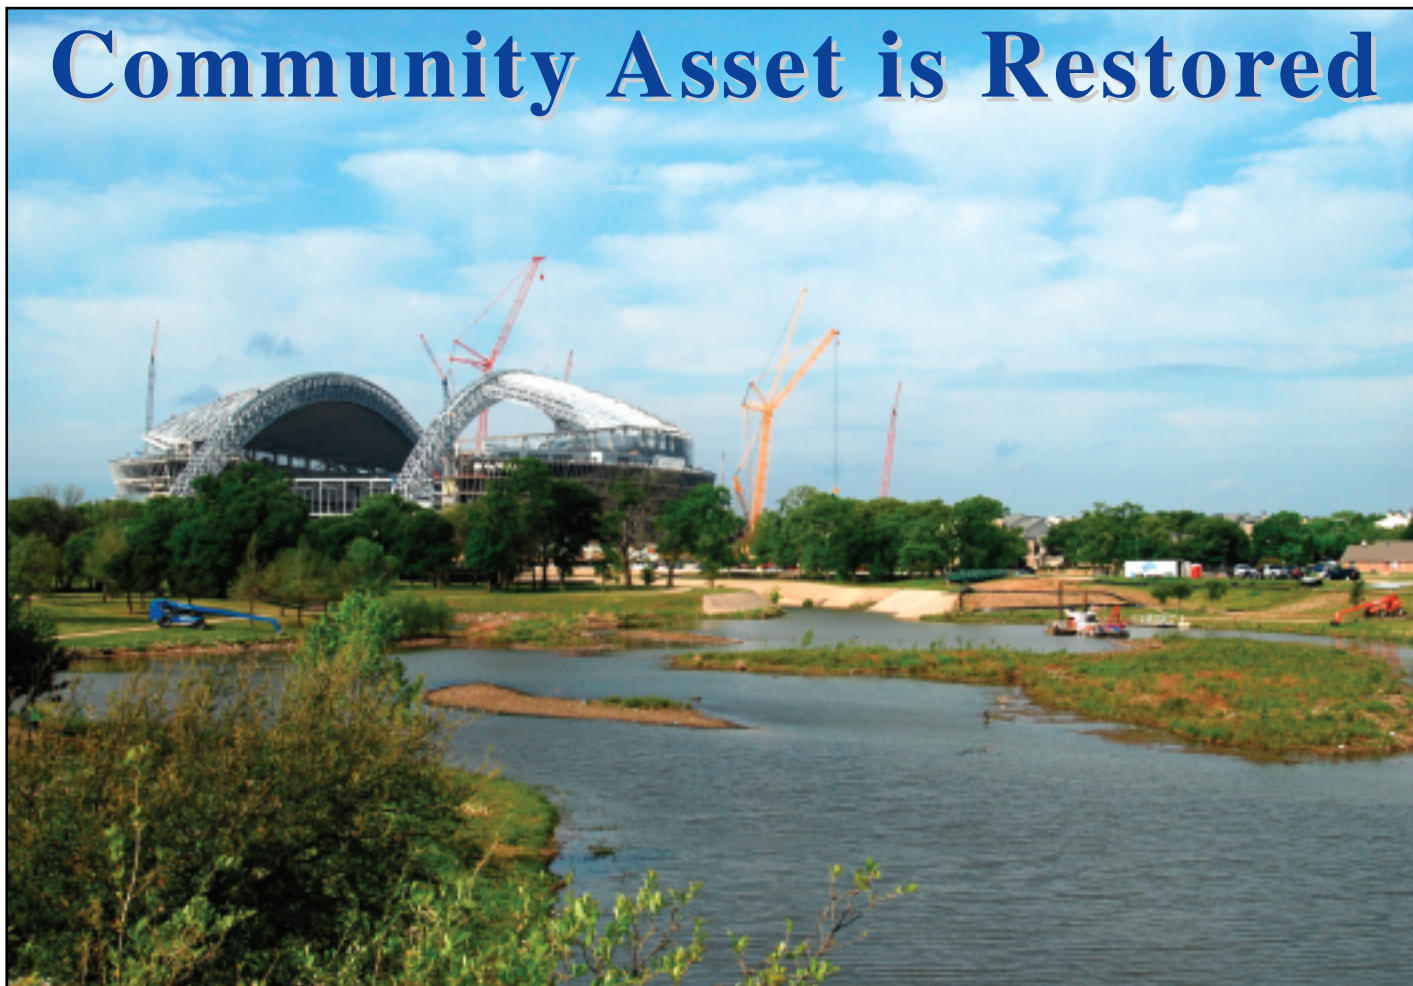
Ranger Lake, which now averages one foot deep or less, sets in the shadows of the new Dallas Cowboys Stadium.

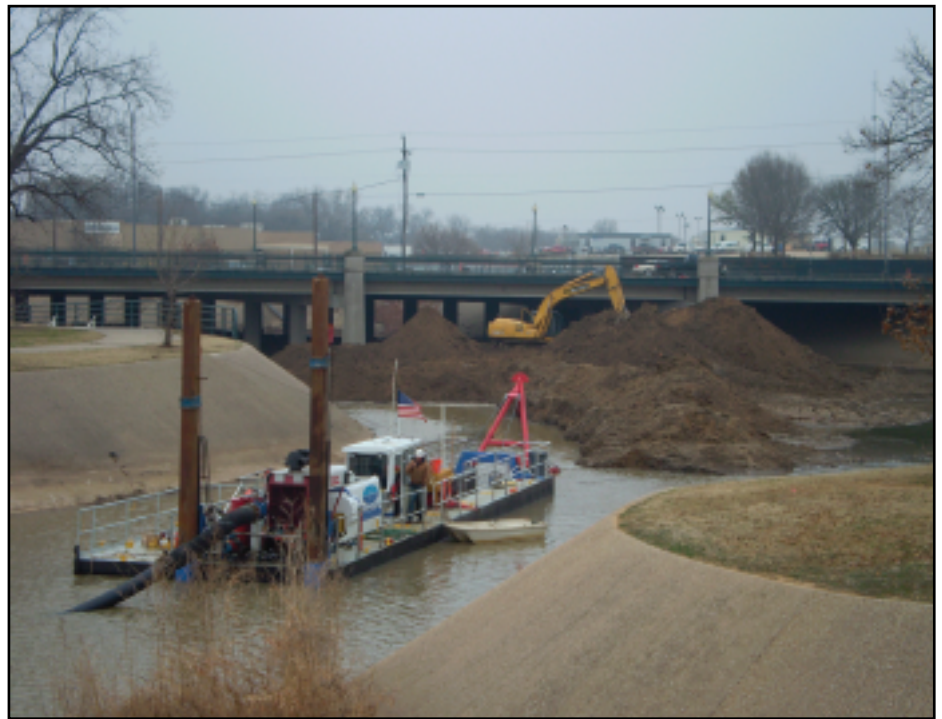
The dredge "Liberty" moves up the creek to remove a large stockpile of material that was pushed "down the creek" with dozers.

Second, there was a large amount of sediment that was upstream of the bridge where the creeks final depth elevations did not allow the dredge to float. The material was moved with dozers to

the downstream side of the bridge where the dredge could pick up the material and pump it to the settling basin upstream.

This apron did not allow enough clearance for the dredge to float up the creek. The dredge needed to get past this bottleneck in order to reach the area upstream where a large amount of built up sediment had to be removed. The dredge drafts 28" and the depth of water at this location was only 24". This problem was solved by temporarily putting

sandbags on top of the overflow dam and raising the level of the lake enough to clear the apron. After this, it was clear

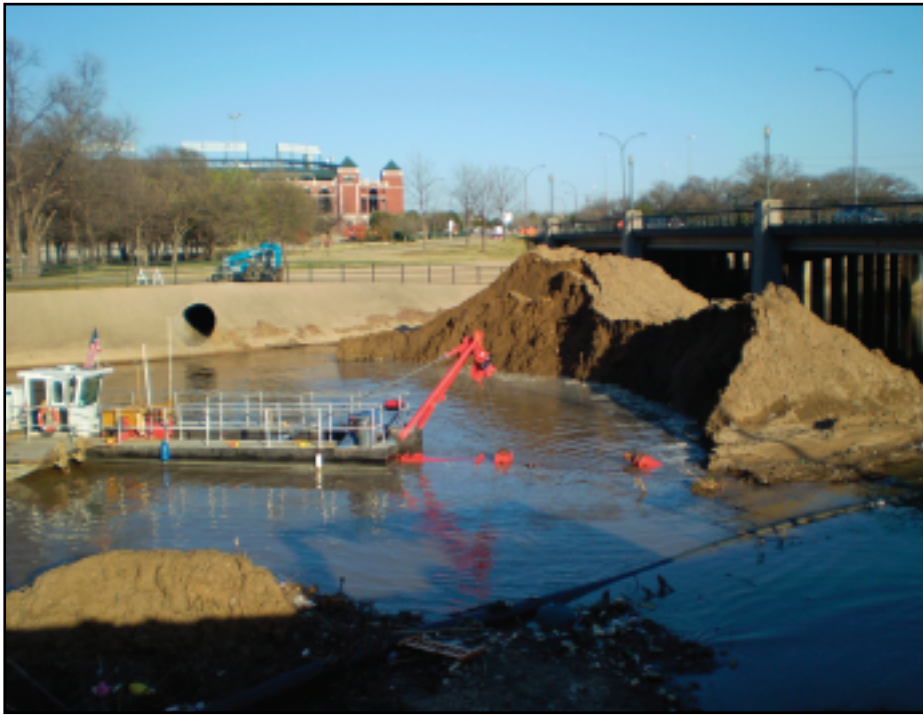
With Ranger Stadium in the background, the dredge chips away at the stockpiled material in the creek and pumps it 1.5 miles to a settling basin.

The contractor mobilized their hydraulic dredge and constructed a temporary 1.5 mile pipeline to pump 110,000 cubic yards of sediment to settling basins constructed upstream. The sediment settled in the basins and the clean water flowed over a flashboard riser where it returned to the lake. A booster pump was utilized in line to ensure the heavy sand was carried the distance.
